Section 22 Connecticut

Connecticut Coastal Structures Inventory Study

PHASE I - NEW LONDON COUNTY

APPENDIX B
MYSTIC QUADRANGLE
RECORDS OF STRUCTURES WITH PHOTOGRAPHS

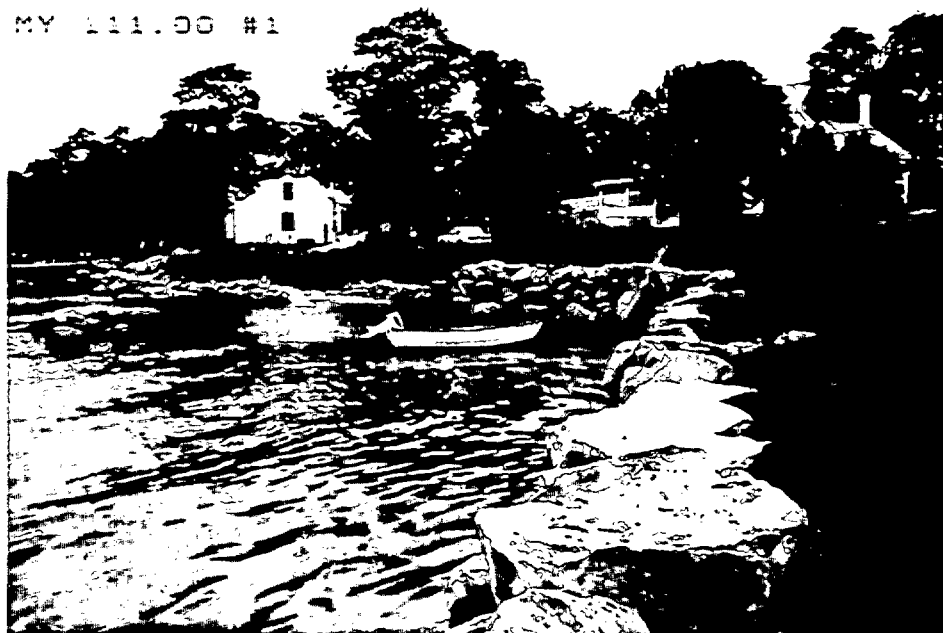
MY 111.00 #1

TYPE OF STRUCTURE: SEAWALL CONDITION: GOOD
MAIN FUNCTION : PREVENT EROSION AND STABILIZE SLOPE
MATERIAL : STONE

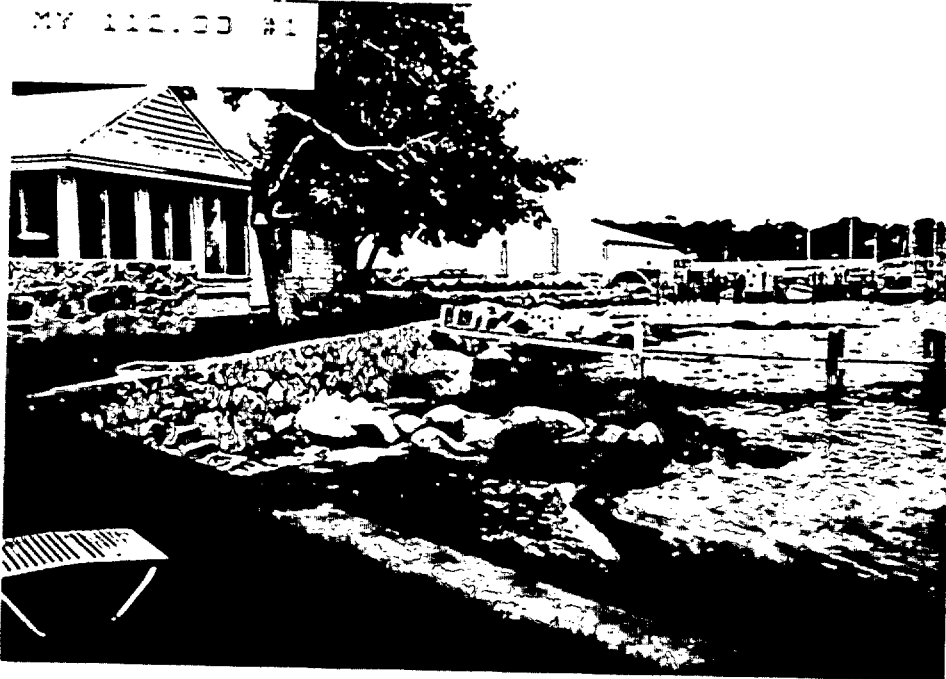
MY 112.00 #1

TYPE OF STRUCTURE: SEAWALL CONDITION: GOOD
MAIN FUNCTION : SUPPORT LAND AND PREVENT EROSION
MATERIAL : STONE IN CEMENT

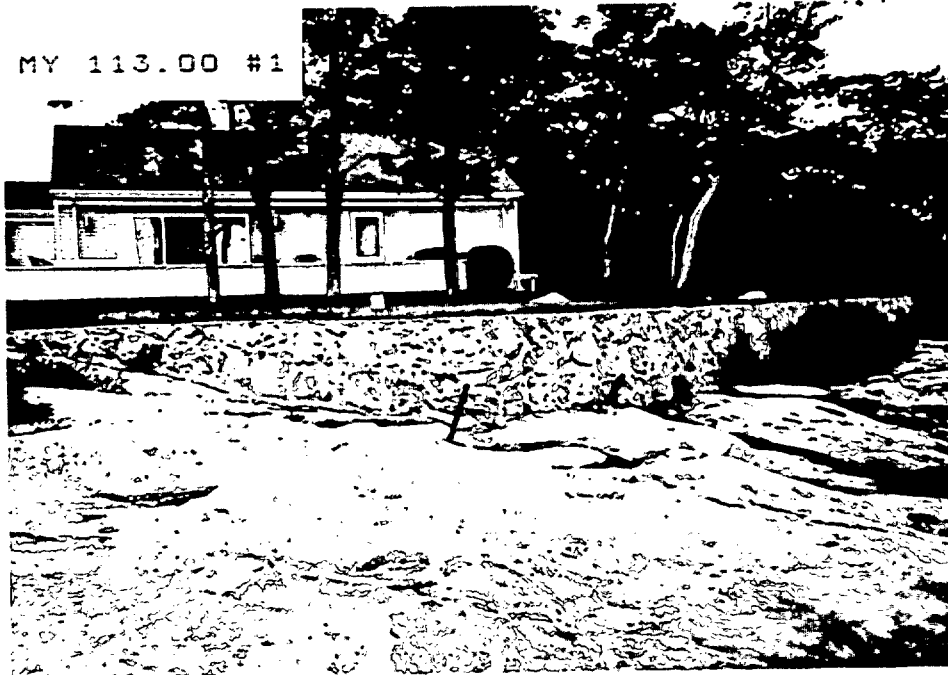
MY 113.00 #1

TYPE OF STRUCTURE: SEAWALL CONDITION: GOOD
MAIN FUNCTION : RETAIN YARD IN FRONT OF HOME
MATERIAL : STONE IN CEMENT

BEDROCK EXPOSURE AT POINT IN FRONT OF SEAWALL

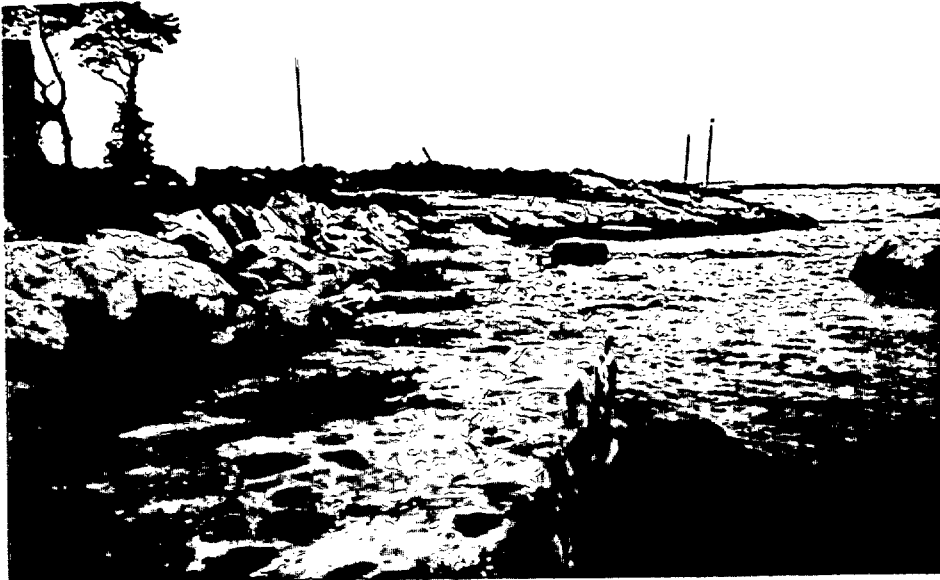
MY 114.00 #1

LOOSE BOULDERS PLACED ON TOP IN SOME PLACES (100 FT)

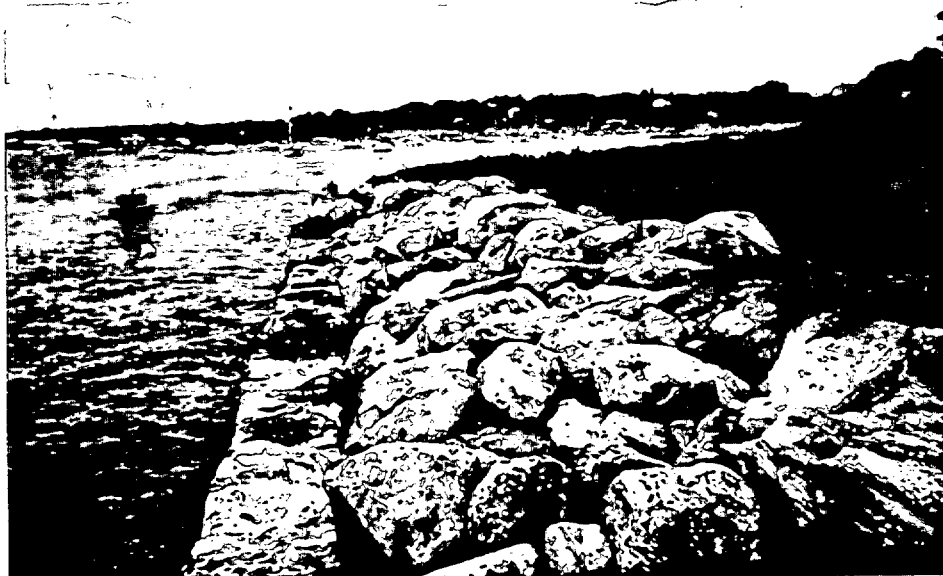
MY 114.00 #2

TYPE OF STRUCTURE: SEAWALL CONDITION: GOOD
MAIN FUNCTION : SUPPORT AND PROTECT LAND, PREVENT EROSION
MATERIAL : STONE IN CEMENT

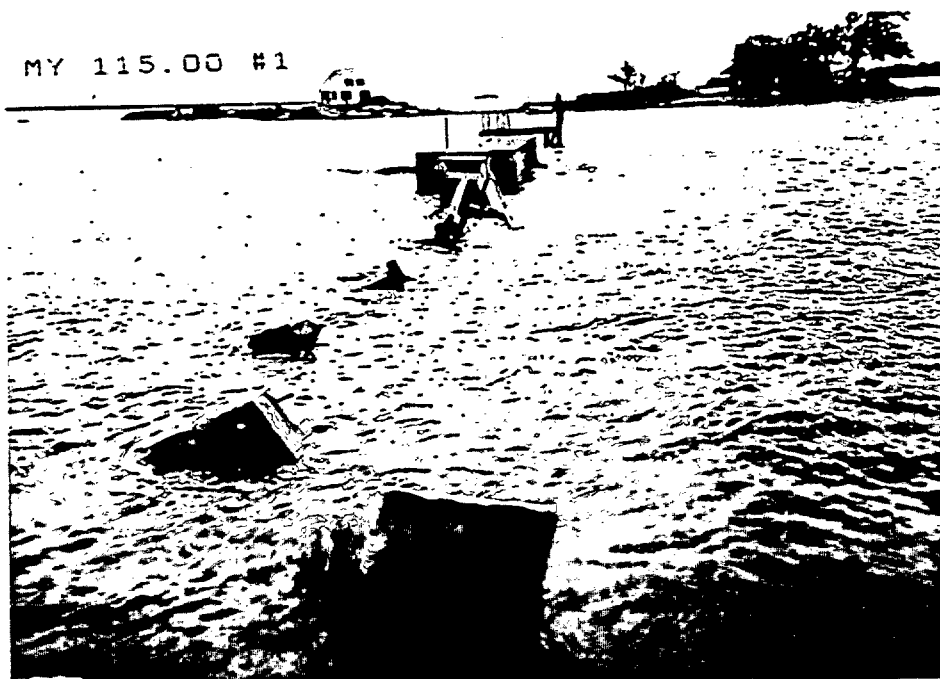
MY 115.00 #1

HAZARD TO NAVIGATION. BEDROCK SHORE - WATER UP TO SEAWALL
AROUND POINT - NO SHORE AREA TO SPEAK OF. OWNER NOTED WOULD
BE REPLACING PIER.

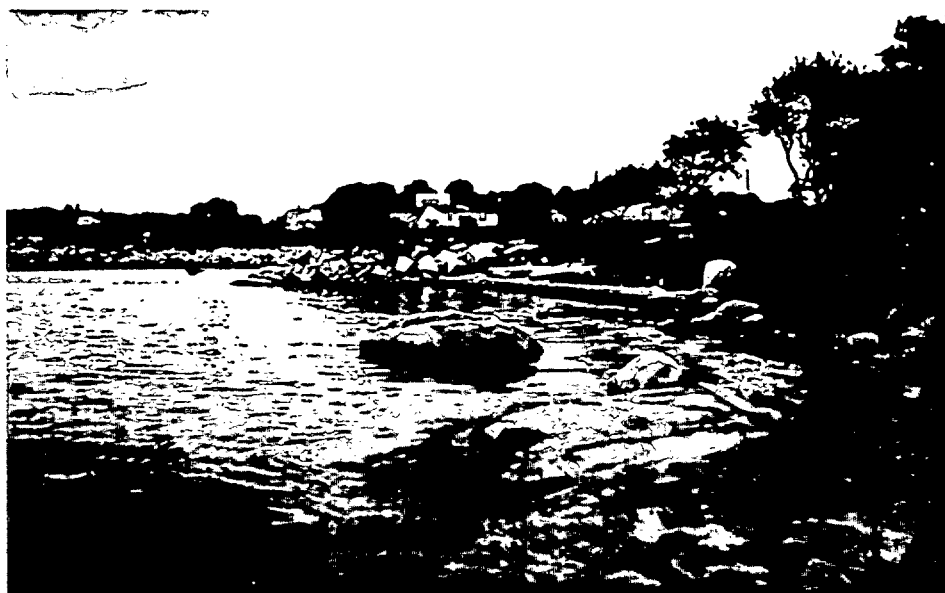
MY 115.00 #1

TYPE OF STRUCTURE: PIER CONDITION: POOR
MAIN FUNCTION : UNKNOWN - POSSIBLY WAS A MOORING
MATERIAL : CONCRETE

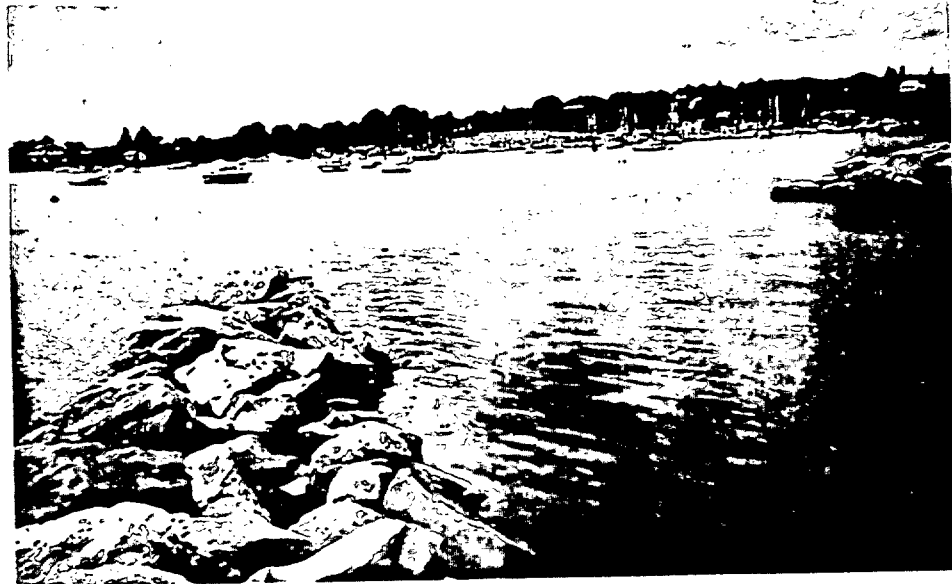
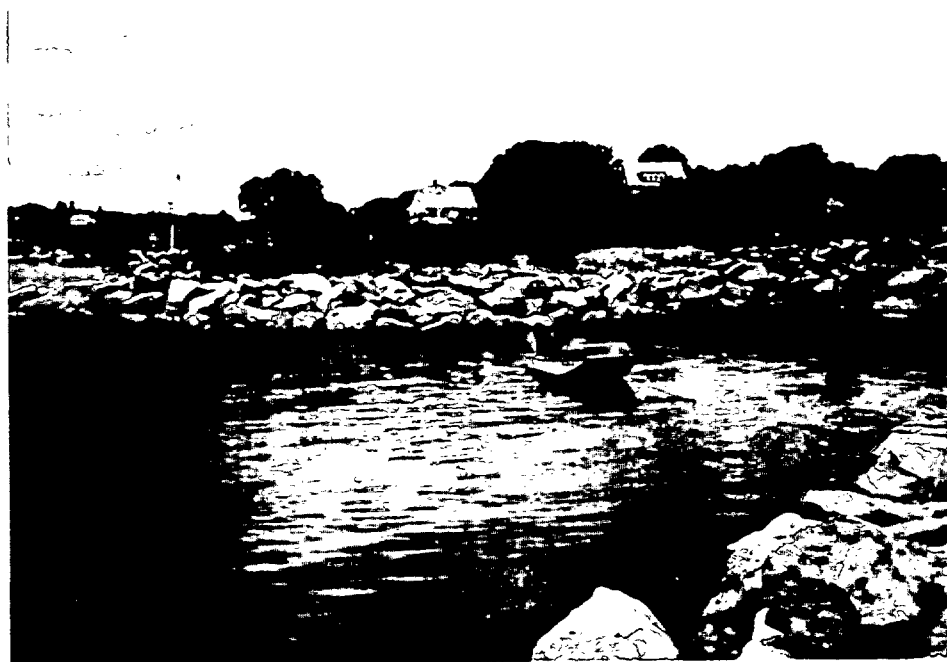
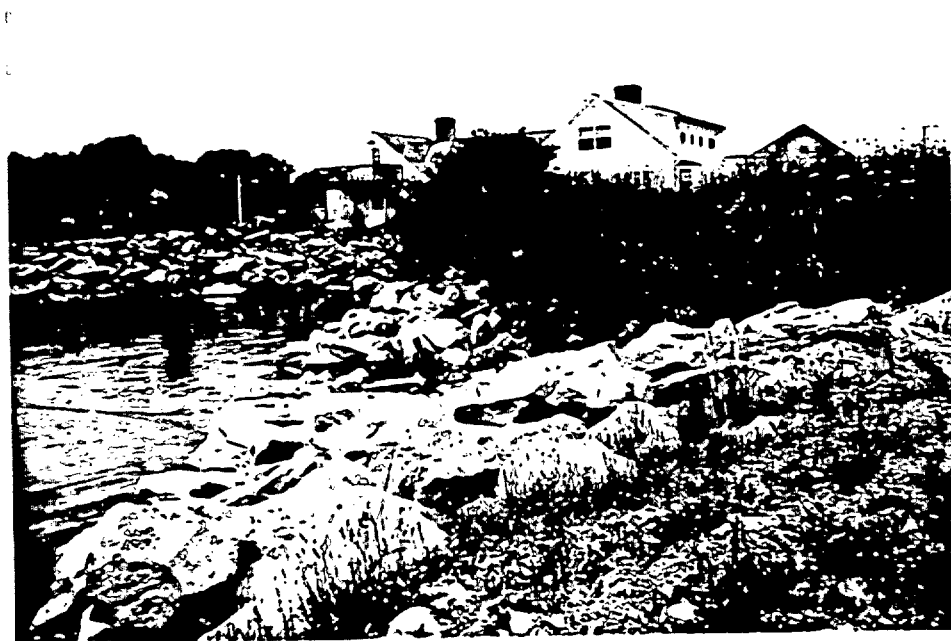
TYPE OF STRUCTURE: REVETMENT CONDITION: GOOD
MAIN FUNCTION : PREVENT EROSION, STABILIZE SHORE, PROVIDE MOORING
MATERIAL : STONE

#1 ROLL 10 NEG 22-24 PANORAMIC VIEW OF STRUCTURE LOOKING NORTH
#2 AND WEST FROM EASTERN CORNER
#3
#4
#5

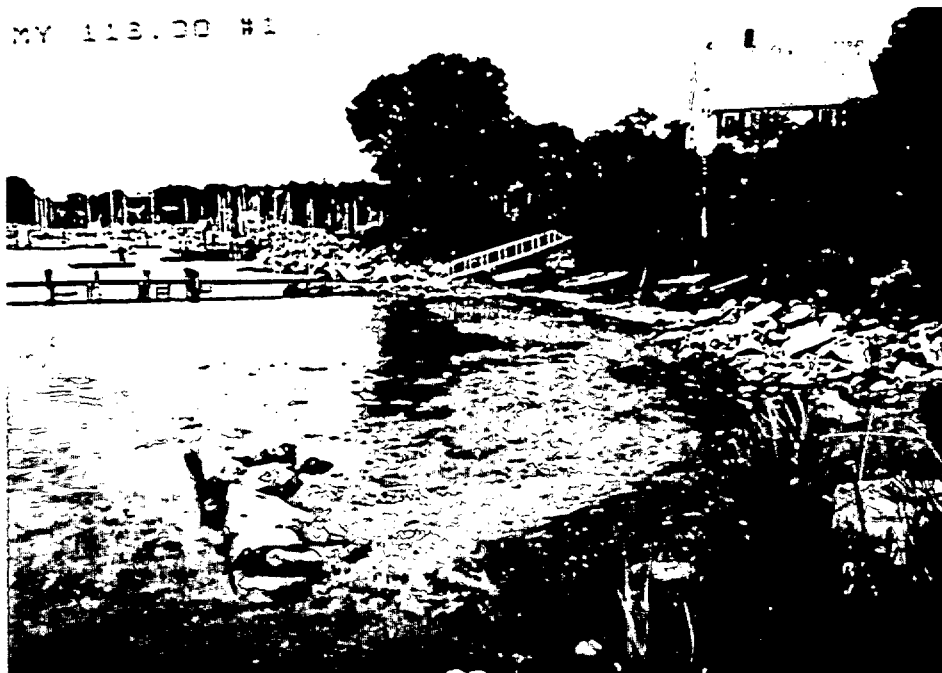
MY 113.00 #1

TYPE OF STRUCTURE: REVETMENT CONDITION: GOOD
MAIN FUNCTION : PROTECT SHORE, PREVENT EROSION
MATERIAL : STONE

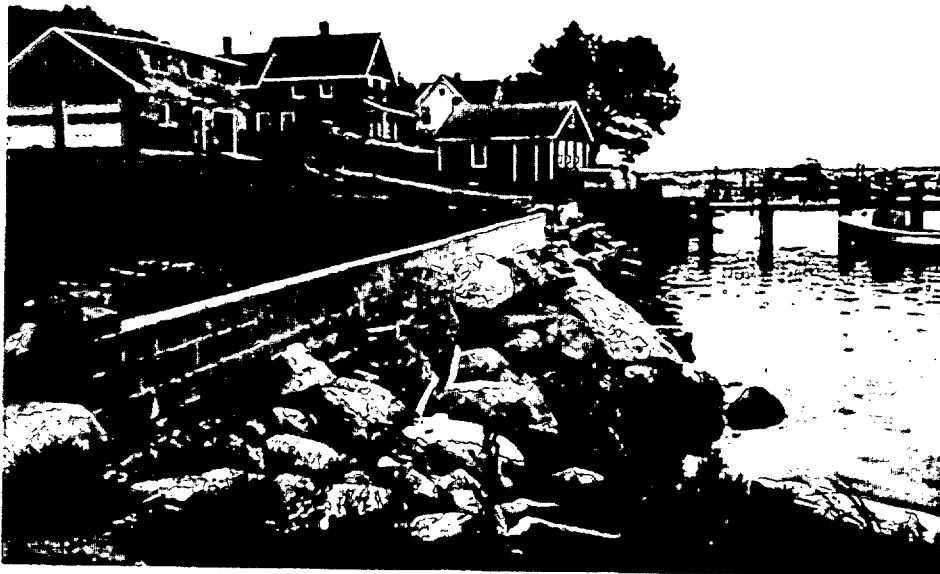
NY 123.00 #1

TYPE OF STRUCTURE: SEAWALL & DOCK CONDITION: FAIR
MAIN FUNCTION : SUPPORT LAND AND PROTECT FROM EROSION
MATERIAL : CINDR BLK/BOLDR

BOULDERS IN FRONT OF SEAWALL

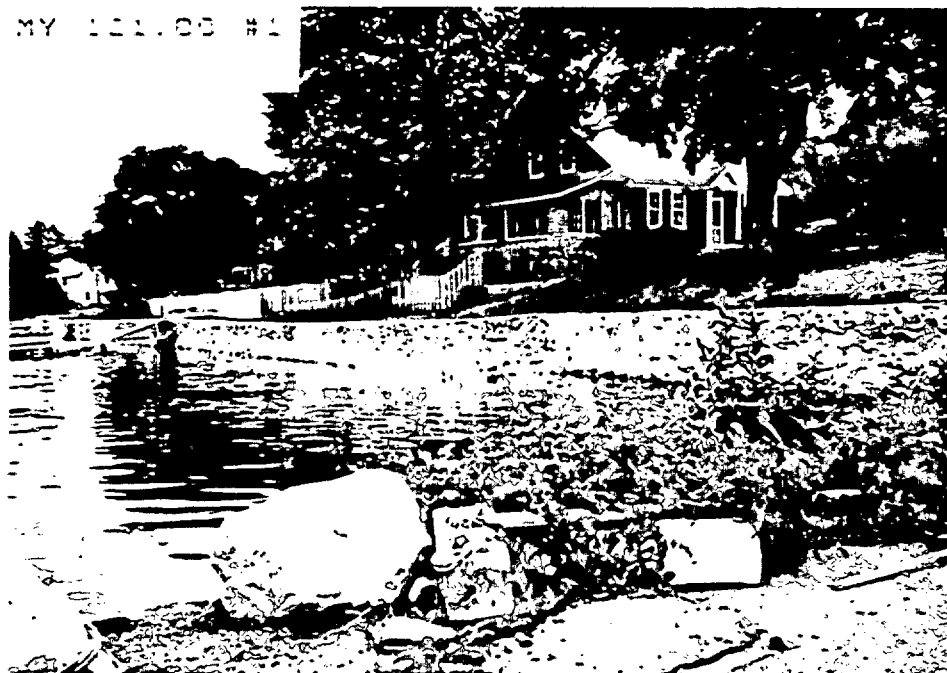
MY 111.00 #1

TYPE OF STRUCTURE: SEAWALL CONDITION: GOOD
MAIN FUNCTION : SUPPORT OF LAND AND EROSION PROTECTION
MATERIAL : STONE IN CEMENT

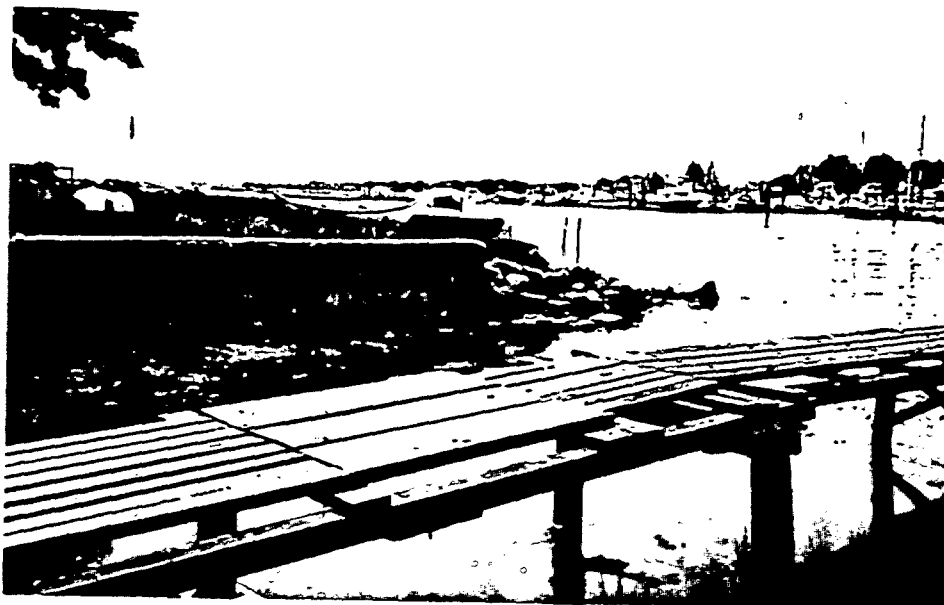
MY 122.00 #1

TYPE OF STRUCTURE: SEAWALL CONDITION: POOR
MAIN FUNCTION : SUPPORT OF LAND AND EROSION CONTROL
MATERIAL : STONE IN CEMENT

SPICES MARINA-COMPLAIN FROM NEIGHBOR-BLOCKING COVE AREA.
TOO MANY MOORINGS FOR COVE. MANY PUBLIC MEETINGS OVER
MARINA AREA.

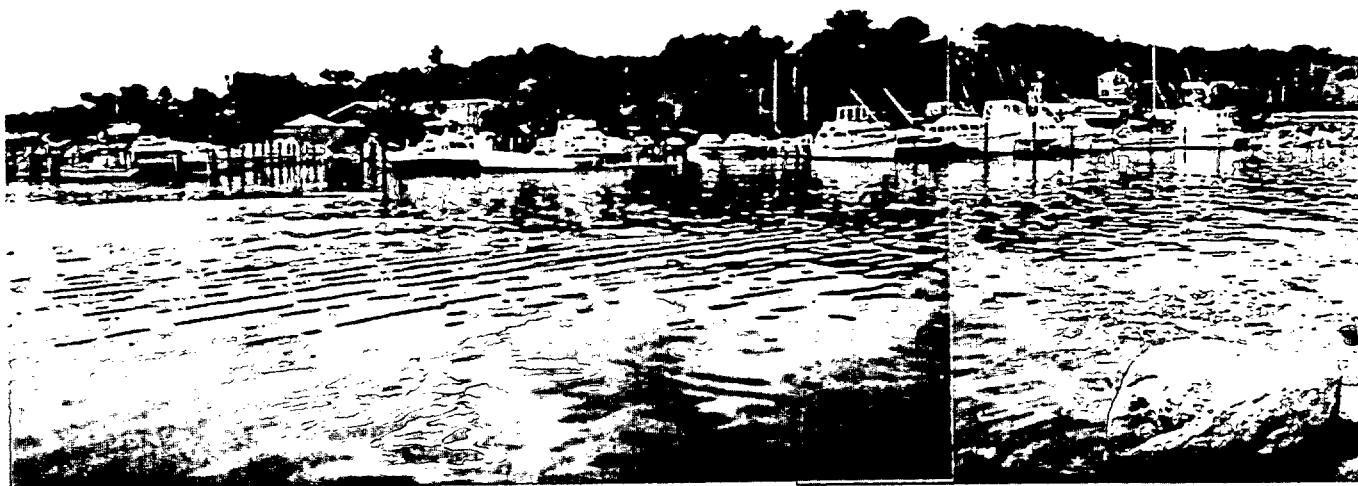
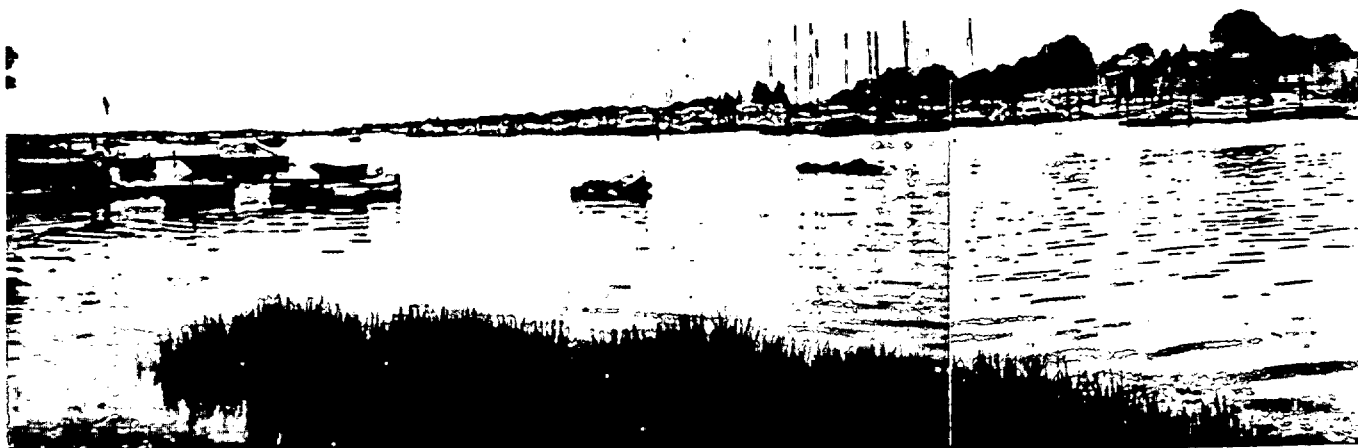
NY 120.00 #1

CONDITION: FAIR

MARINA HAS TAKEN OVER WEST BANK OF WEST COVE. SEAWALLS USED
FOR MOORING.

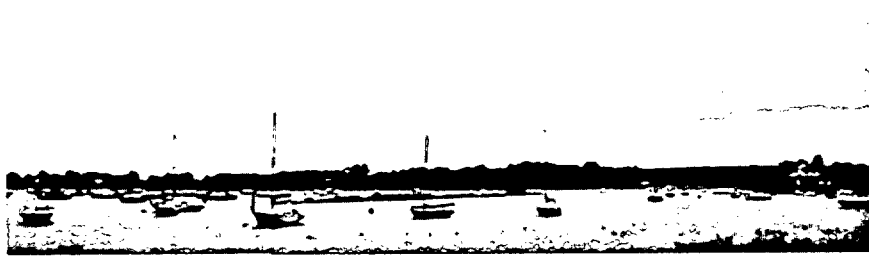
MY 124.00 #1

TYPE OF STRUCTURE: BREAKWATER CONDITION:
MAIN FUNCTION : PROTECTION OF MOORING AREA
MATERIAL : TIMBER & STONE

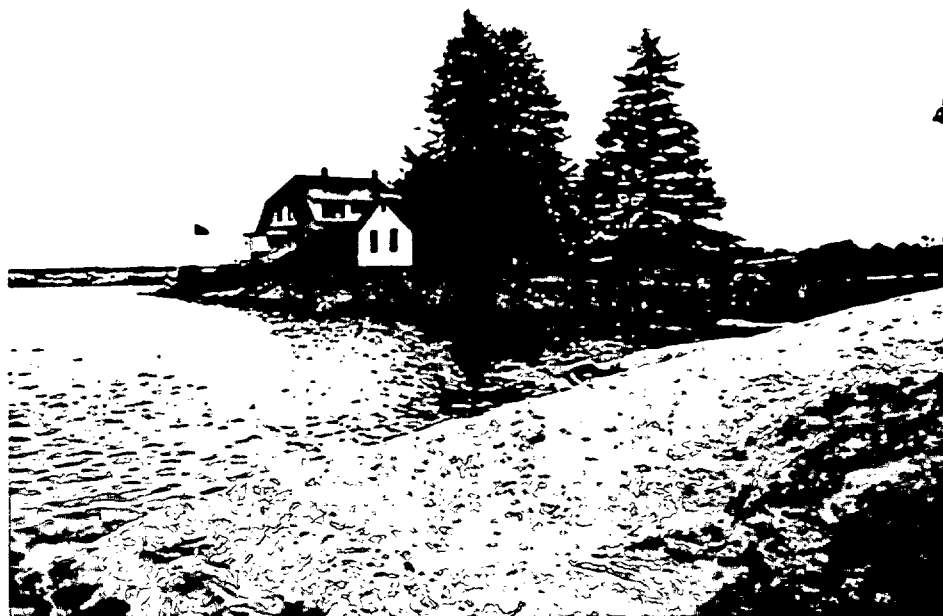
MY 125.00 #1

TYPE OF STRUCTURE: SEAWALL CONDITION: GOOD
MAIN FUNCTION : BANK STABILIZATION
MATERIAL : CEMENTED ROCK

NATURAL BEDROCK EXPOSED. SEAWALL PROTECTS GRASS YARD AND
HOUSE FROM SALTWATER. LOCATED SOUTH OF SPICERS MARINA.

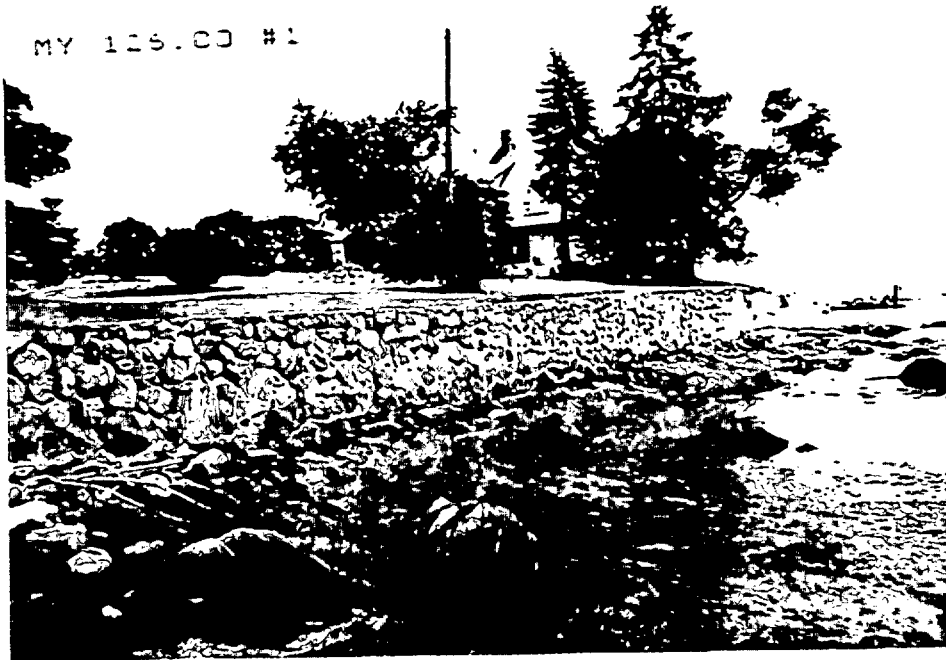
MY 125.00 #1

EXPOSED BEDROCK AT POINT BETWEEN STRUCTURES 125 AND 126

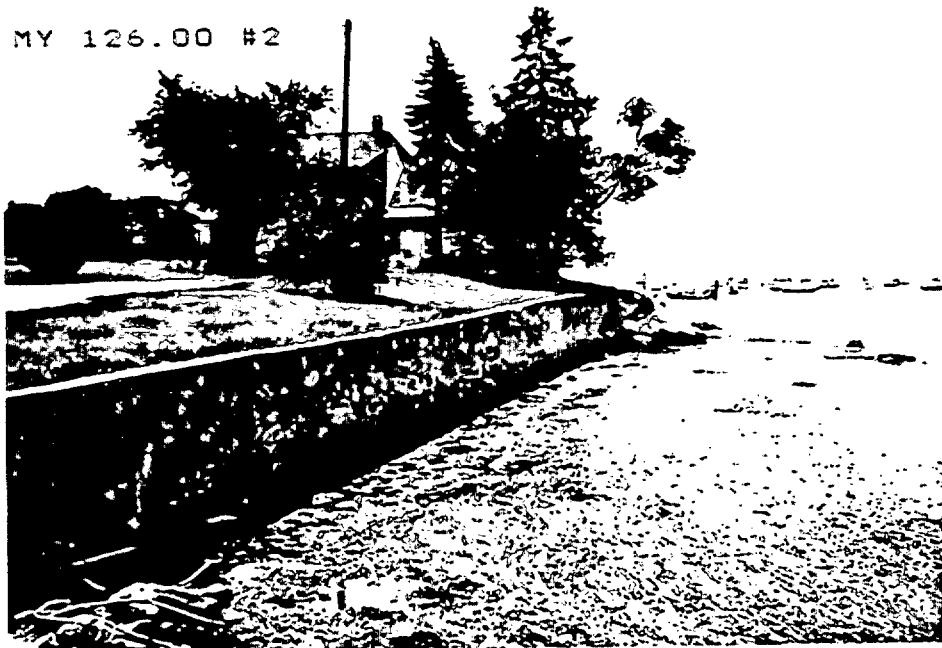
MY 126.00 #2

TYPE OF STRUCTURE: SEAWALL CONDITION: GOOD
MAIN FUNCTION : SHORE STABILIZATION AND PROTECTION
MATERIAL : STONE IN CEMENT

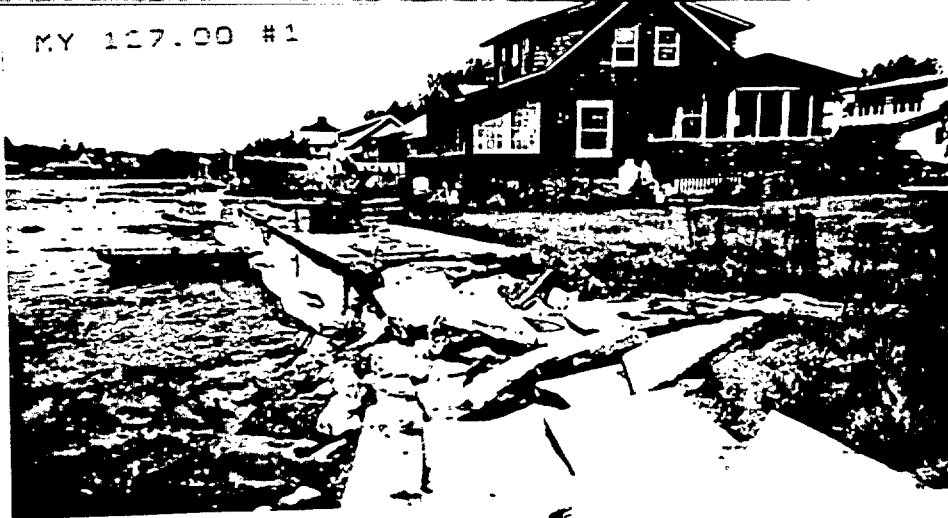
MY 127.00 #1

DAMAGE PROBABLY CAUSED BY SCOUR AND EROSION. OWNER SAYS A
CATAMARAN HIT DAMAGED AREA DURING HURRICANE GLORIA.

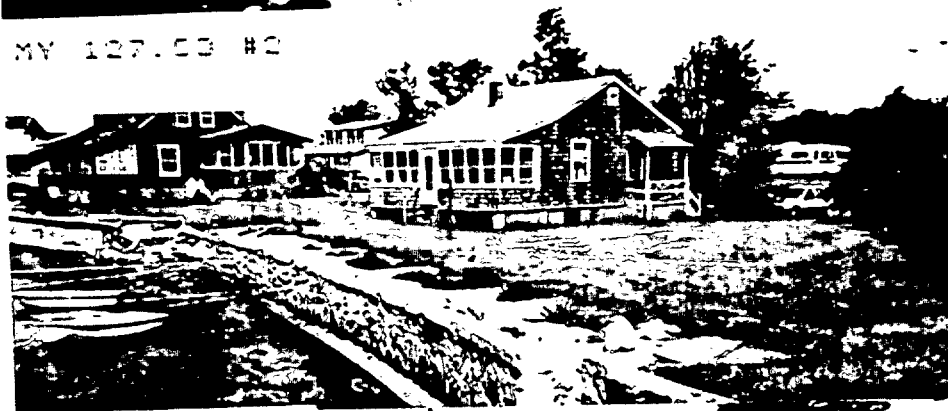
MY 127.00 #2

TYPE OF STRUCTURE: SEAWALL CONDITION: POOR
MAIN FUNCTION : SUPPORT OF LAND AND EROSION PROTECTION
MATERIAL : STONE IN CEMENT

#1 ROLL 11A NEG 15 SEAWALL FROM EAST
#2 ROLL 11A NEG 16 DAMAGED AREA FROM EAST
#3 ROLL 15 NEG 4 SEAWALL FROM EAST
#4 ROLL 15 NEG 6 DAMAGED AREA FROM WEST
#5

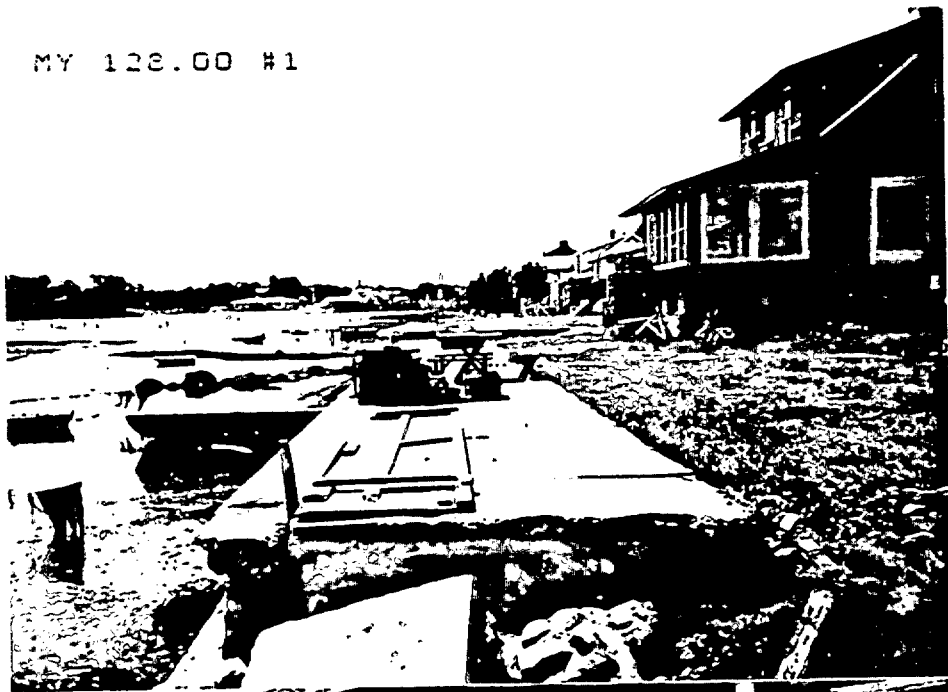
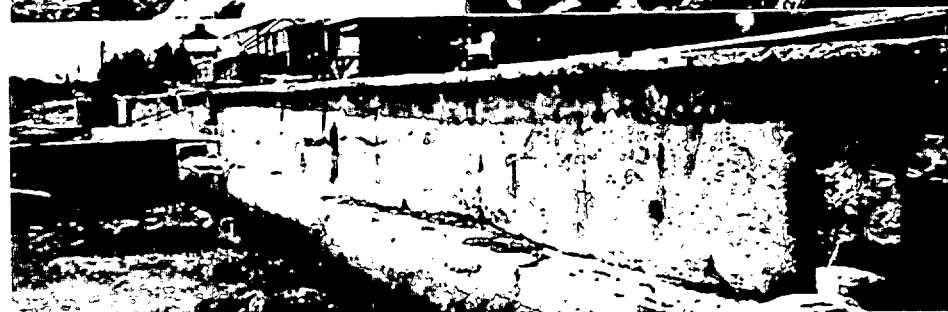
MY 128.00 #1

TYPE OF STRUCTURE: SEAWALL CONDITION: POOR-FAIR
MAIN FUNCTION : SUPPORT OF LAND AND EROSION PREVENTION
MATERIAL : CEMENT

BOAT RAMP ON WEST END OF STRUCTURE. PUBLIC RIGHT OF WAY TO
BOAT RAMP.

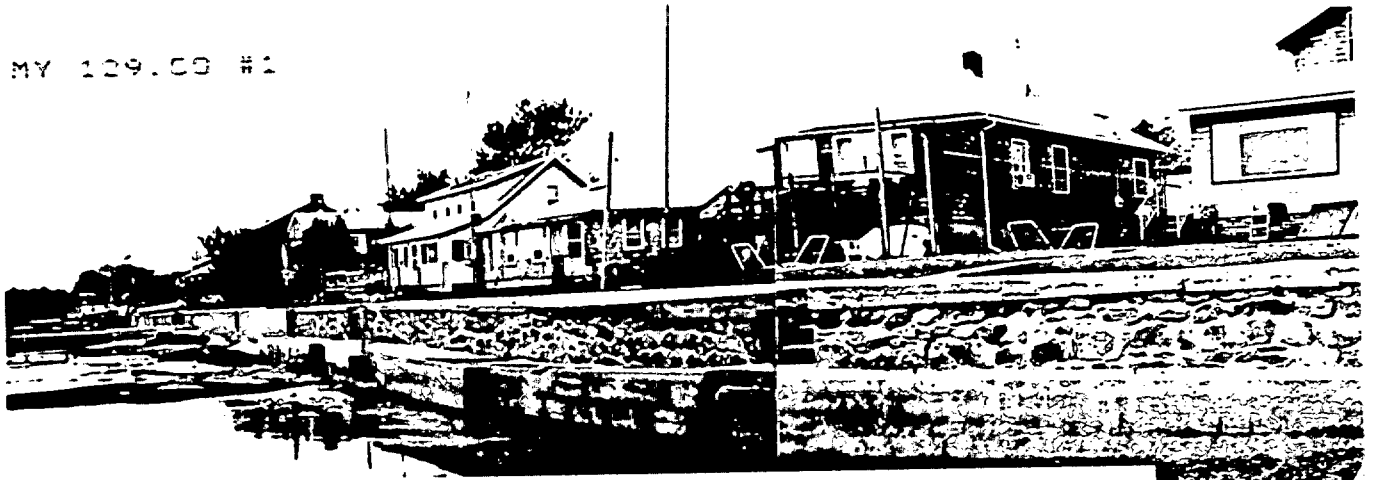
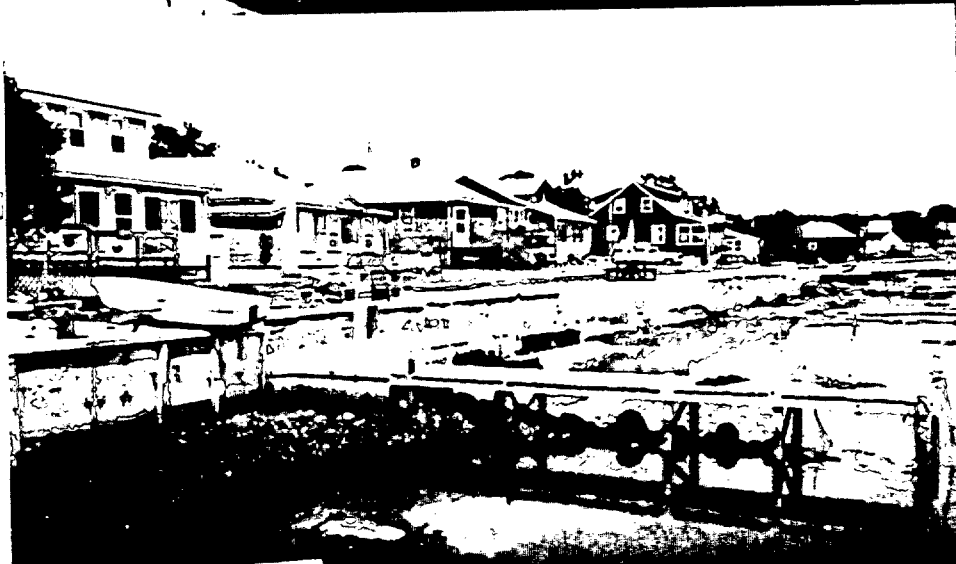
MY 129.00 #1

OWNER NOTED PORTIONS OF SEAWALL HAVE BEEN REPLACED SINCE
HURRICANE GLORIA. 2 DOCKS OFF SEAWALL. PART OF SEAWALL IS
WOODEN.

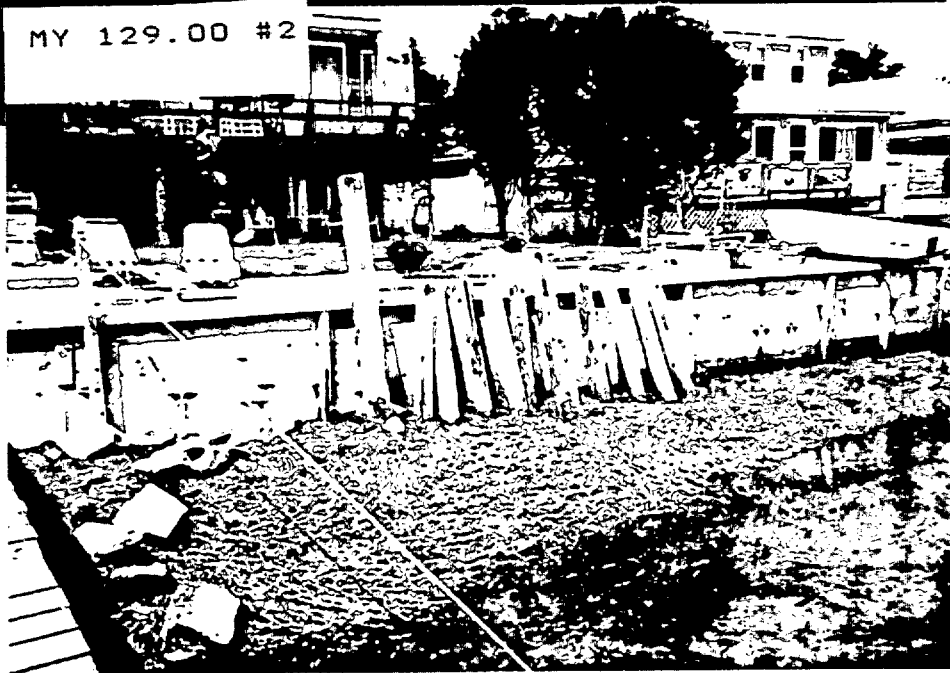
MY 129.00 #2

TYPE OF STRUCTURE: SEAWALLS&DOCKS CONDITION: FAIR
MAIN FUNCTION : PREVENT EROSION
MATERIAL : STONE, CONCRETE

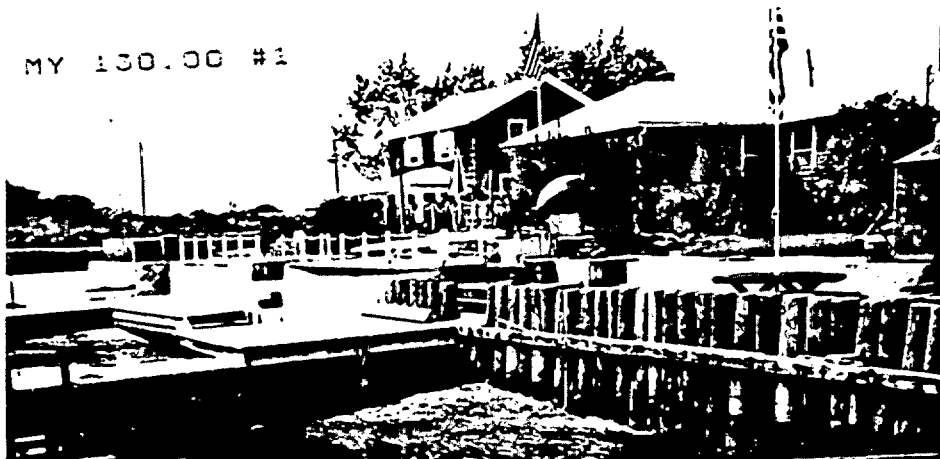
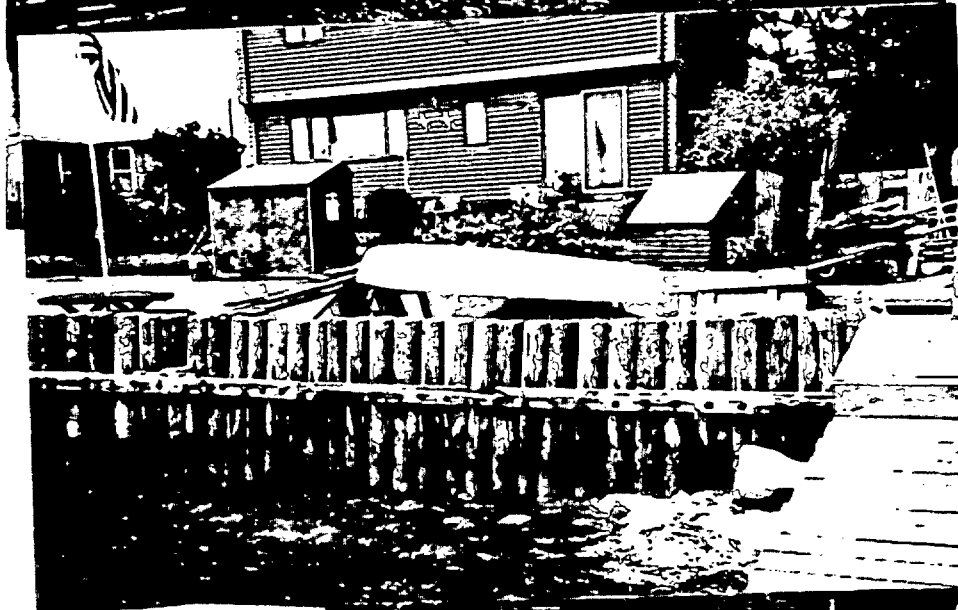
MY 130.00 #1

TYPE OF STRUCTURE: SEAWALL CONDITION: GOOD
MAIN FUNCTION : SUPPORT OF LAND AND SHORE PROTECTION
MATERIAL : CEMENT+WOODPILE

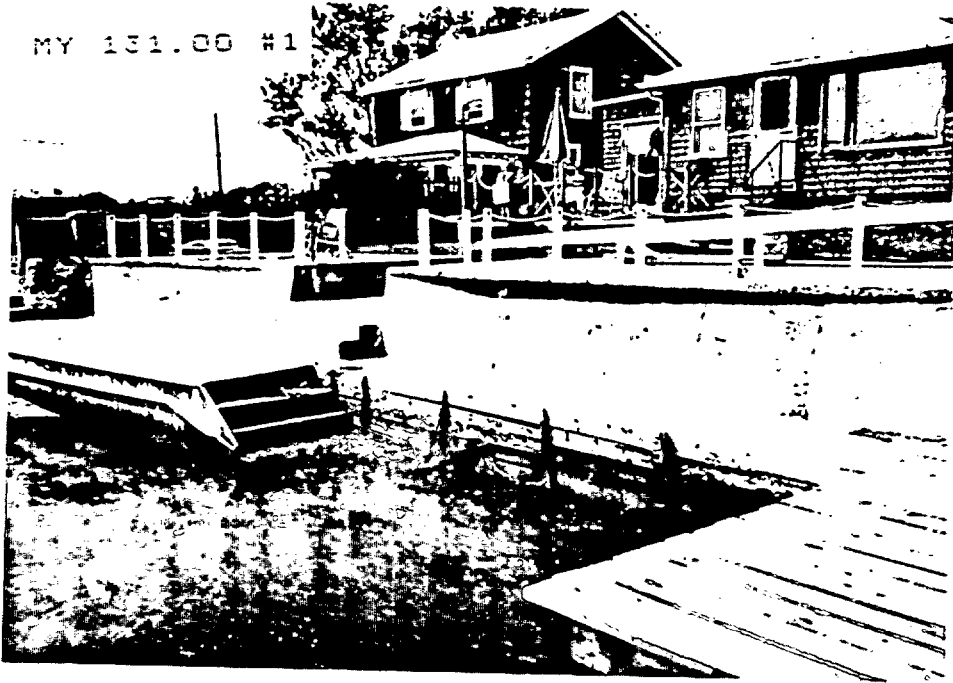
MY 131.00 #1

TYPE OF STRUCTURE: SEAWALL CONDITION: FAIR
MAIN FUNCTION : BANK PROTECTION
MATERIAL : CEMENT AND WOOD

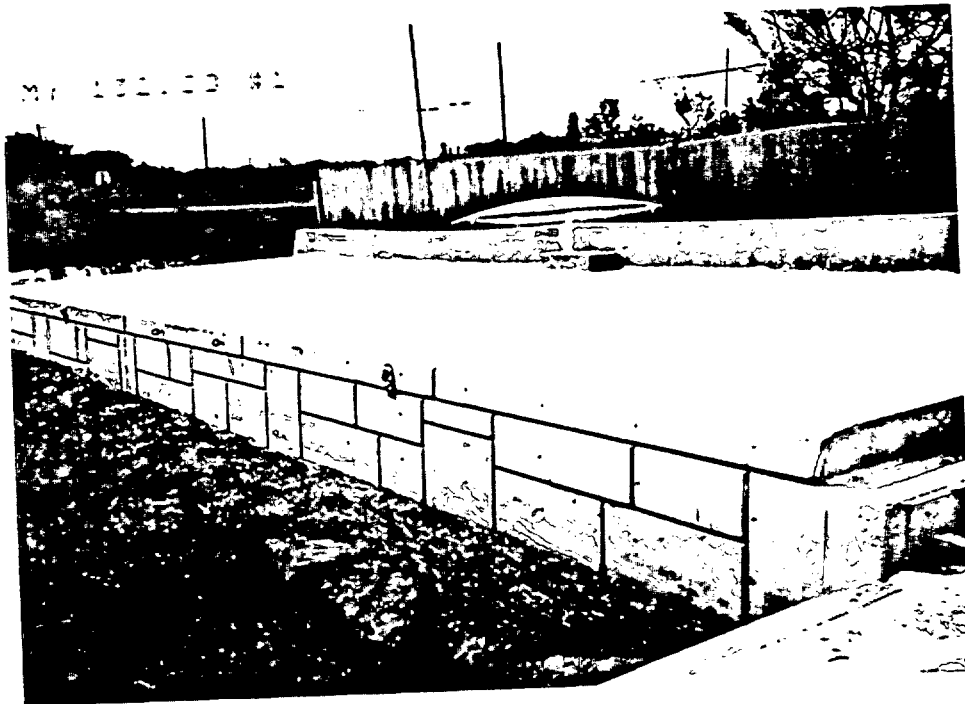
TYPE OF STRUCTURE: SEAWALL CONDITION: GOOD
MAIN FUNCTION : EROSION PROTECTION OF LAND IN FRONT OF HOME
MATERIAL : CEMENT

#1 ROLL 12 NEG 5 SEAWALL
#2 ROLL 12 NEG 6,7 ESKER BEACH FROM STRUCTURE
#3
#4
#5

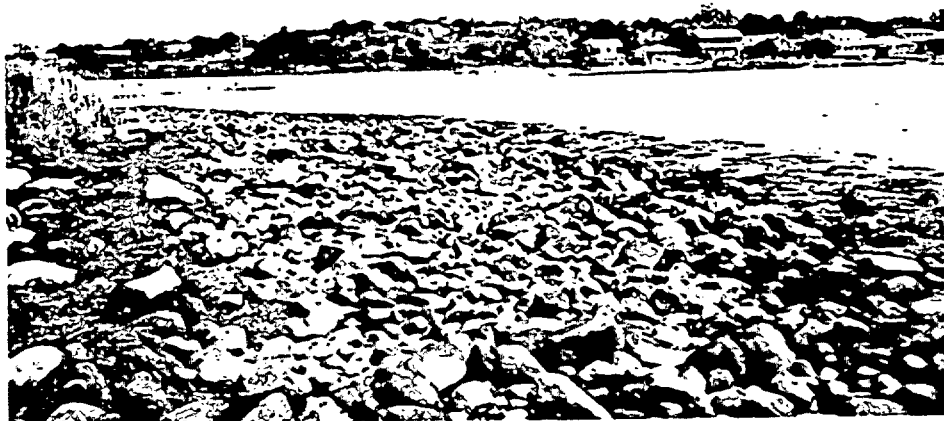
MY 133.00 #1

TYPE OF STRUCTURE: RIPRAP CONDITION: GOOD
MAIN FUNCTION : PROTECTION OF SHORELINE
MATERIAL : STONE & ROCK

ESKER BEACH-BEACH AREA WITH SWIMMING AND PICNIC TABLES AND
CONCESSION STAND (FOOD). PAID PARKING ACROSS STREET.

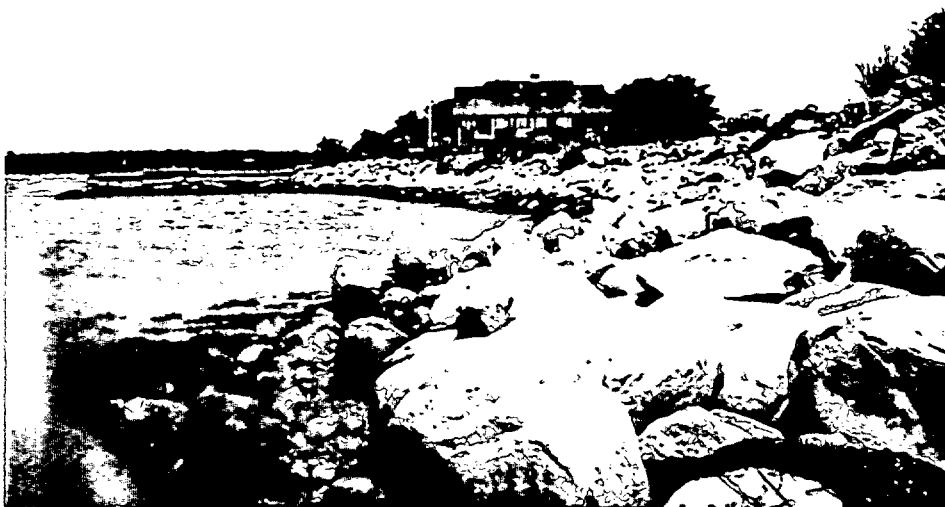
MR 174.35 #1

TYPE OF STRUCTURE: RIPRAP & DOCK CONDITION: GOOD
MAIN FUNCTION : PROTECTION OF SLOPE
MATERIAL : STONE & ROCK

MARSHY SMALL BEACH AREA BETWEEN 133 AND 134. CONTINUATION
OF 133.
